Space Shuttle Orbiter Approach and Landing Test Evaluation Report

Captive-Active Flight Test Summary

September 1977

National Aeronautics and
Space Administration

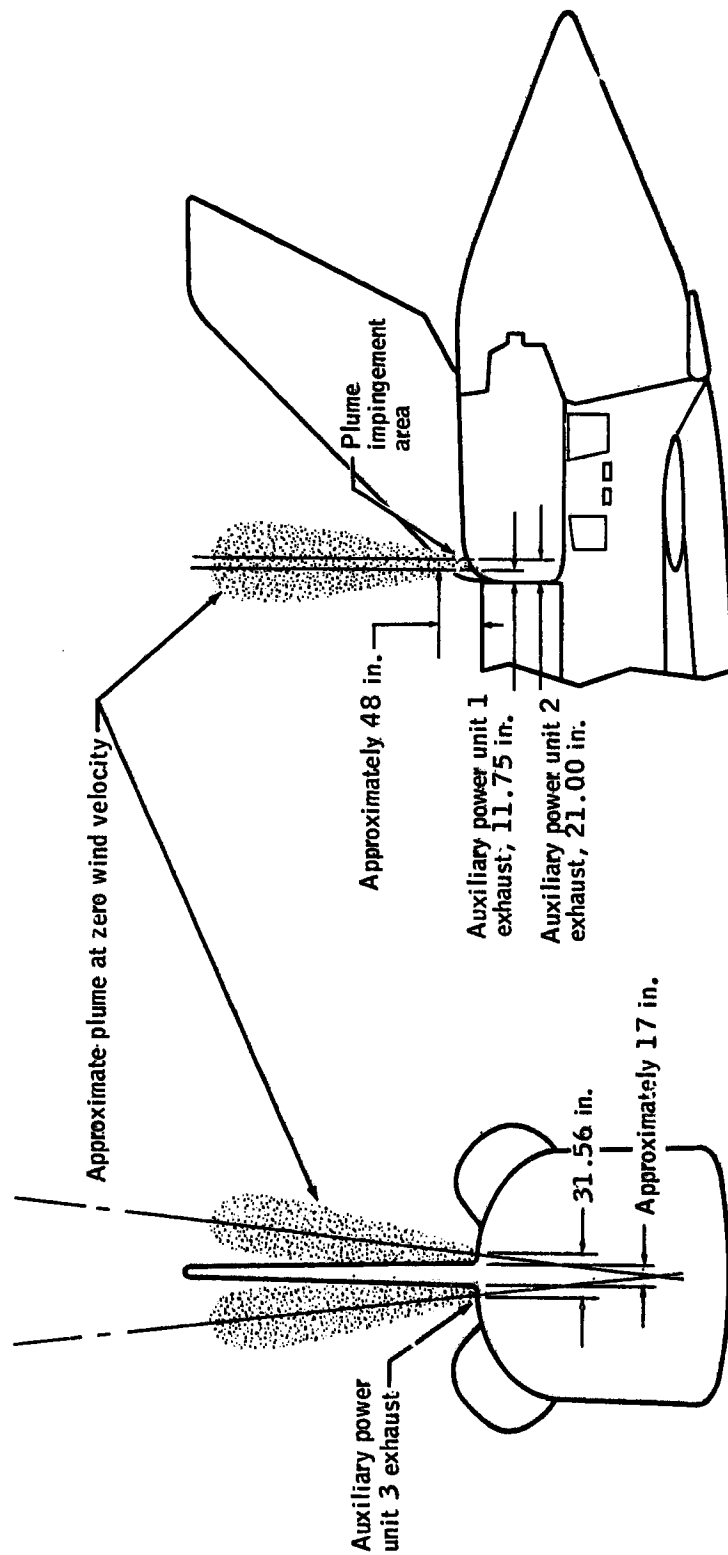
Figure 3-1.- Auxiliary power unit exhaust plumes.

Following the first flight, ground personnel reported seeing a flame in the exhaust plume from auxiliary power units 1 and/or 2 after landing. Inspection of the exhaust impingement area (fig. 3-1) revealed only minor effects. After the vehicle turned off the runway following the second flight, ground personnel again observed flame in the exhaust plume of auxiliary power units 1 and/or 2. Limitations for operating the auxiliary power units preflight and postflight were established for the third flight; however, no flame was observed during ground operations.

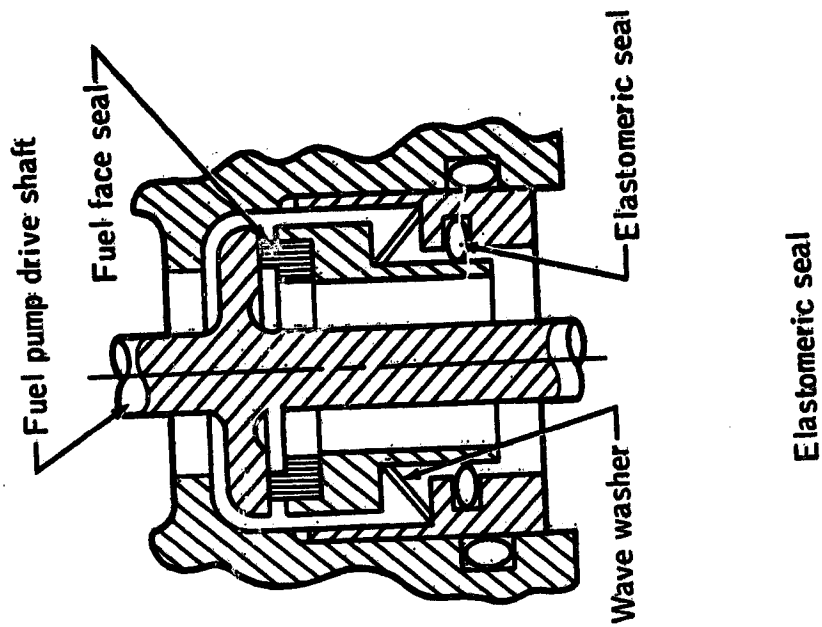
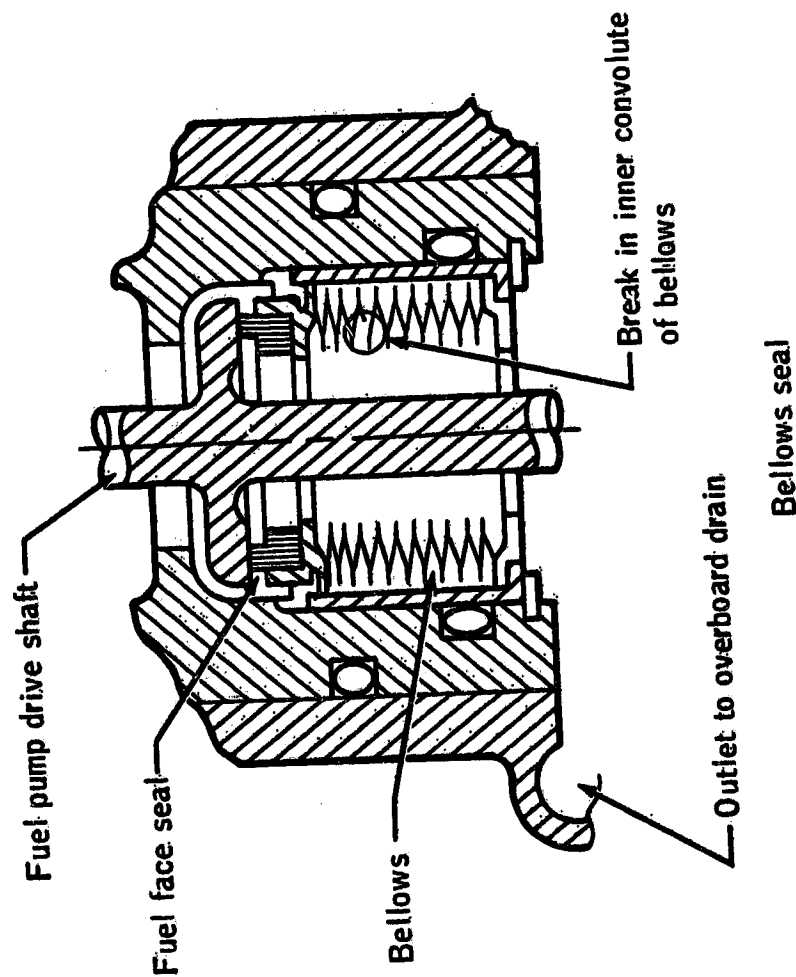
Figure 6-2. - Auxiliary power unit fuel pump seals.

Approximately 18 minutes into the flight, auxiliary power unit 1 was activated as planned. There was an increase in the rate of fuel usage for the unit about 25 minutes after activation. It was determined postflight that failure of the auxiliary power unit 1 fuel pump bellows seal had caused extensive hydrazine leakage.

About 30 to 45 minutes after auxiliary power unit shutdown following the second flight, the pump inlet pressure of unit 1 decayed to 34 psi, indicating fuel (hydrazine) leakage. This indication was supported by an increased rate of unit 1 fuel usage about 25 minutes after activation. Postflight inspection revealed that there had been excessive leakage from the auxiliary power unit 1 fuel cavity drain. This anomaly is discussed in paragraph 6.4.

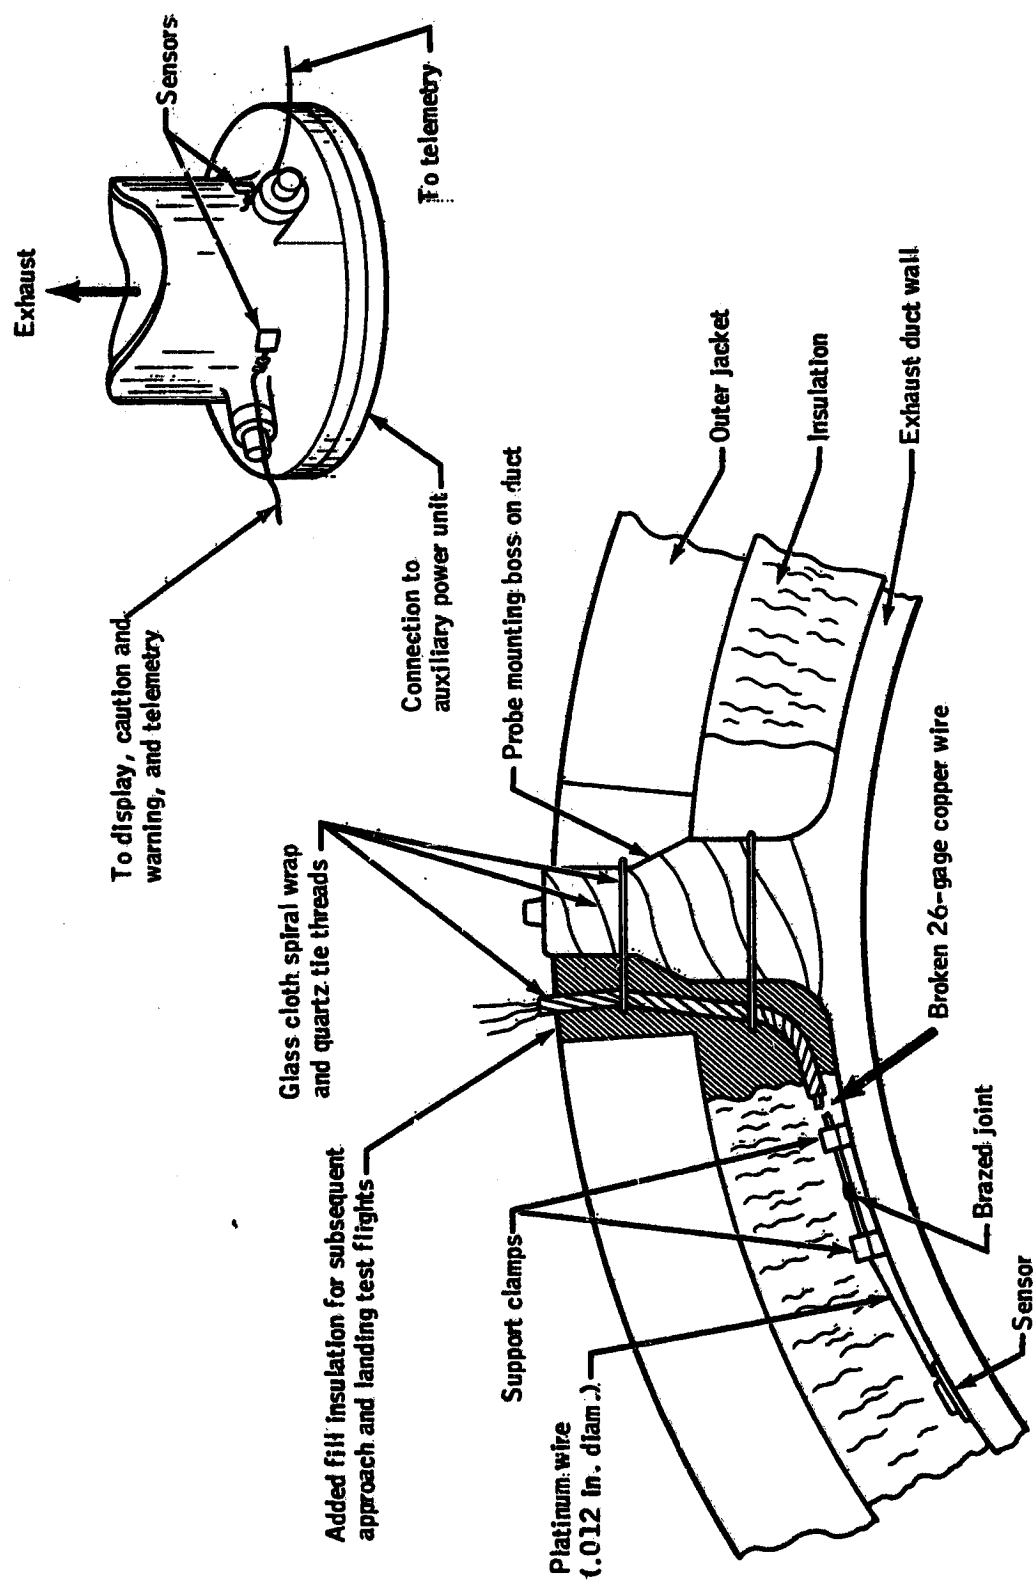
Figure 6-10. - Auxiliary power unit exhaust duct temperature measurement.

On the third flight, about 4 minutes after start-up, a faulty transducer produced a false indication of auxiliary power unit 1 exhaust gas over-temperature. The crew responded to this alarm by shutting down auxiliary power unit 1. The flight continued normally using auxiliary power units 2 and 3. Postflight inspection showed that auxiliary power unit 1 had leaked about 22 cc of fuel during inflight operation. A ground hot-fire test resulted in only 8 cc of leakage in 30 minutes. This was within limits and no corrective action was required. During postflight data analysis, erratic vibration data were observed from four accelerometers associated with auxiliary power unit 1. This condition was determined to be an instrumentation problem. (See par. 3.5.2.)

Corrective action taken for the remainder of the Approach and Landing Test flights includes (1) the addition of fill insulation (fig. 6-10) to better protect the copper lead from the high temperature of the boss and provide support to dampen lead movement and minimize flex stress by the hold-down clamp and (2) provide readout of the redundant temperature measurement in the cabin for crew monitoring. A probe-type sensor in the boss is being considered for Orbital Flight Test.
